Alba Power Station 5 Block 4 Supplementary ESIA Contaminated Land Risk Assessment

January 2023
1B0114202
Rev. 01_Final

Title	Alba Power Station 5 Block 4 Contaminated Land Risk Assessment
Date	23 January 2023
Author	Rajith Chandran

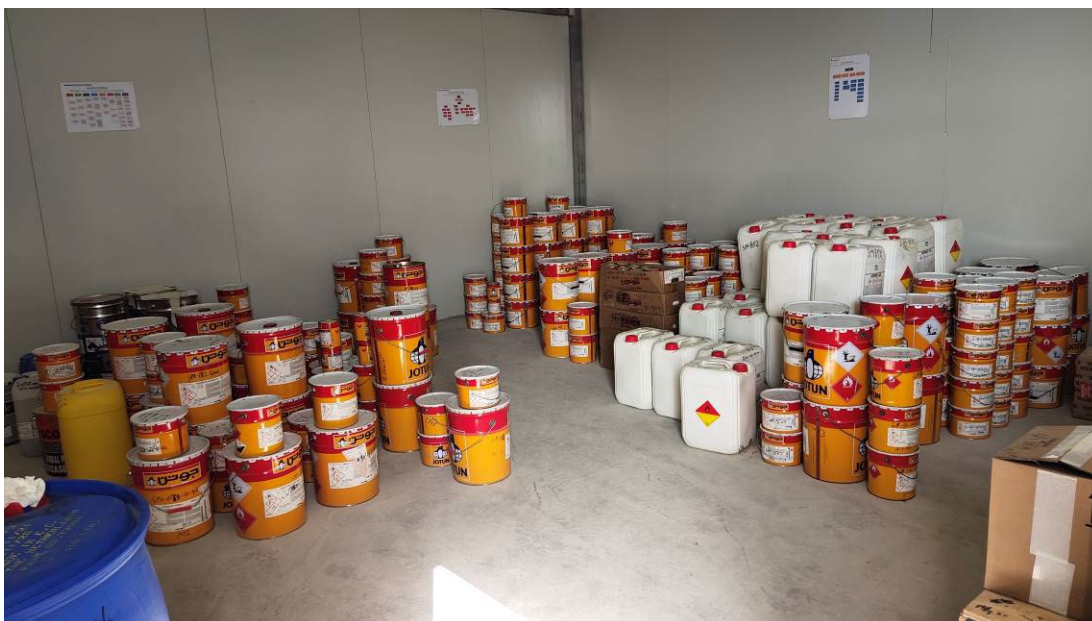
Figure 3.4 Chemical storage area

The chemical storage area (**Figure 3.4**) contains an impervious concrete floor, air conditioning, spill kits, fire extinguishers and ventilation. Material such as paint and electrolyte liquids purchased for the Al Dur Phase II IWPP are still stored in the area. However, these materials are owned by First National Operation and Maintenance Co. Ltd. (NOMAC) and will be transferred to the storage area in Al Dur Phase II power plant. The chemical store was clean with no sign of spill or contamination observed on the floor of the warehouse or in adjacent areas.

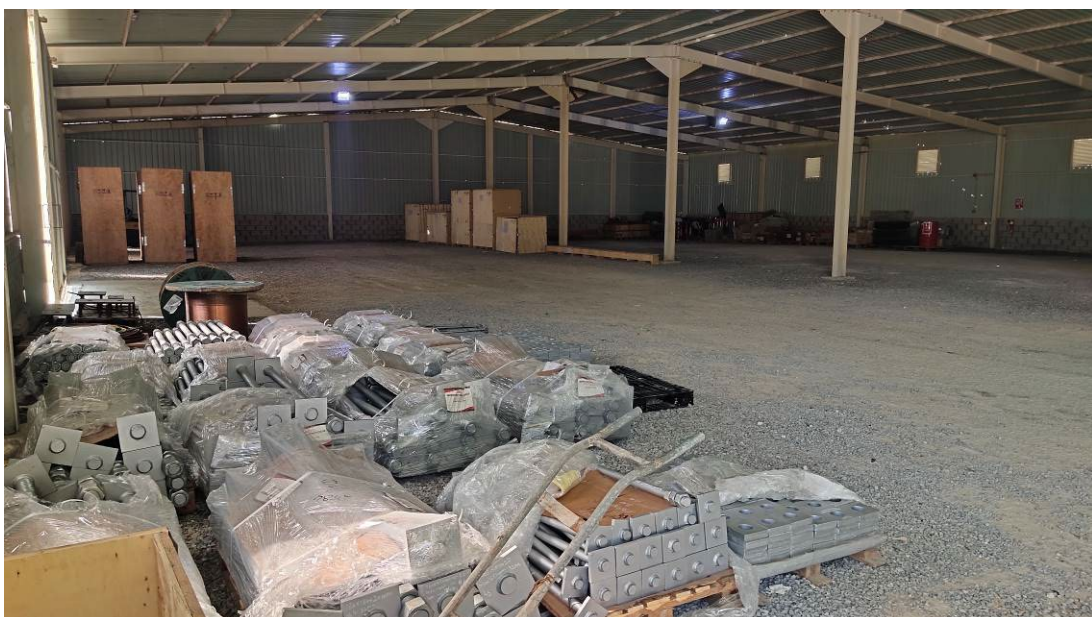
Figure 3.5 Warehouse

The warehouse was inspected (**Figure 3.5**). Materials for Al Dur Phase II Project remain stored in both the warehouse and open yard. These will be transferred to Al Dur Phase II power plant area. Housekeeping is excellent, the warehouse and open yard were both very well organised with no visible contamination observed on the ground or at adjacent areas.

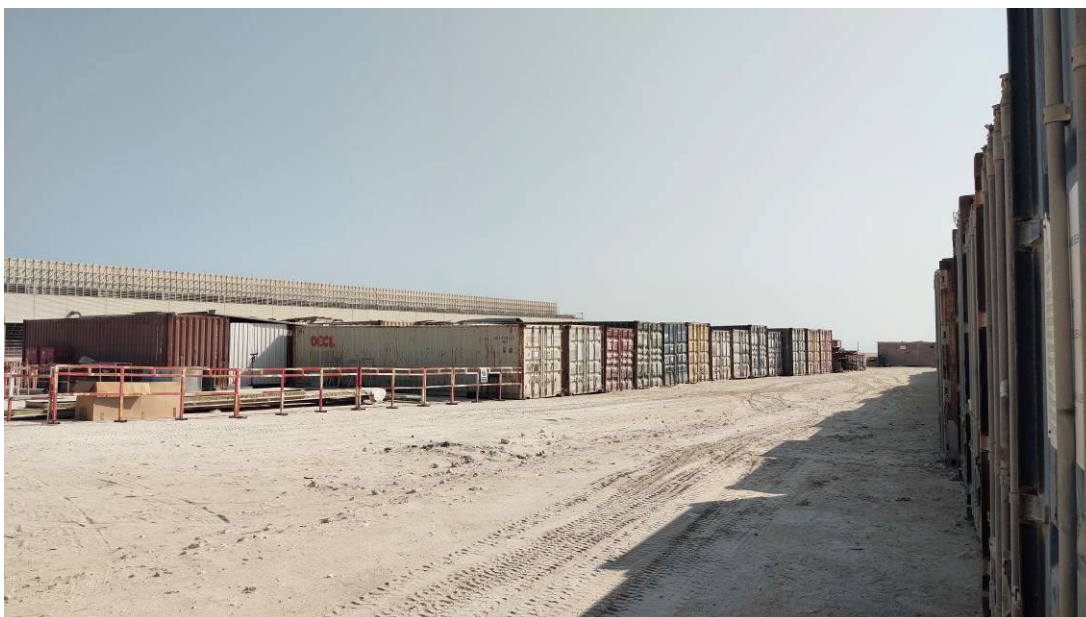
Figure 3.6 Storage containers at laydown yard

A total of 130 containers were stored in the open yard during the site visit (**Figure 3.6**). The containers belong to Al Dur Phase II IWPP. Out of 130, 95 containers contain spare parts for Al Dur Phase II IWPP and the balance of 35 are empty. The containers were well organised and the containers and their contents present no risks to the environment.

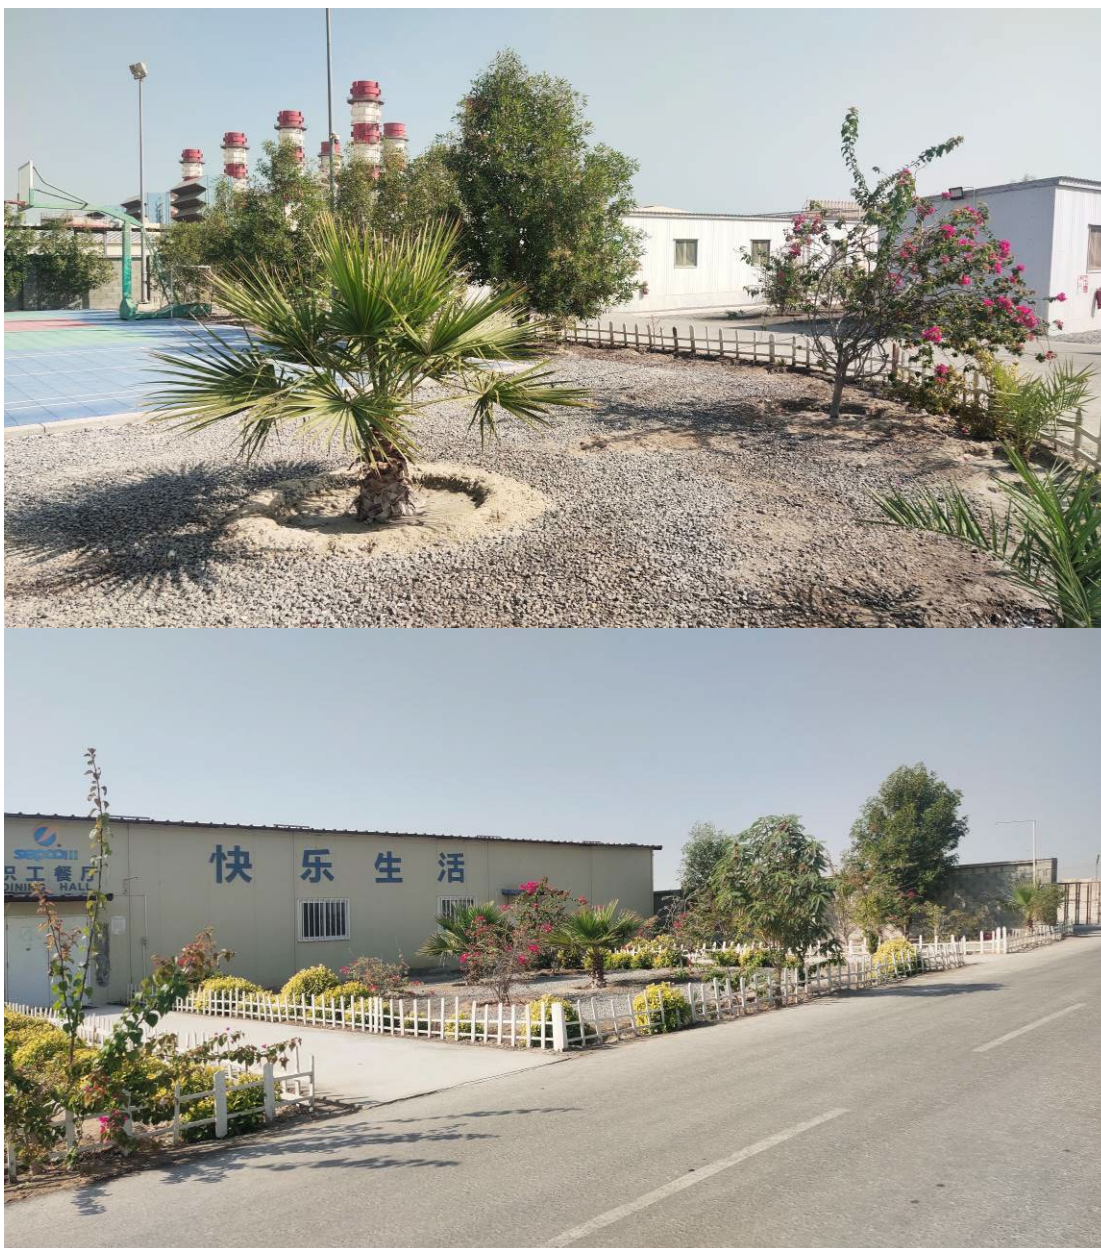
Figure 3.7 Vegetation observed at accommodation area

No evidence of historical chemical discharges or releases (i.e., staining or stressed vegetation) was observed during the site visit. Various species of plant are planted in the accommodation area where the laydown yard for Al Dur Phase I IWPP was located (**Figure 3.7**).

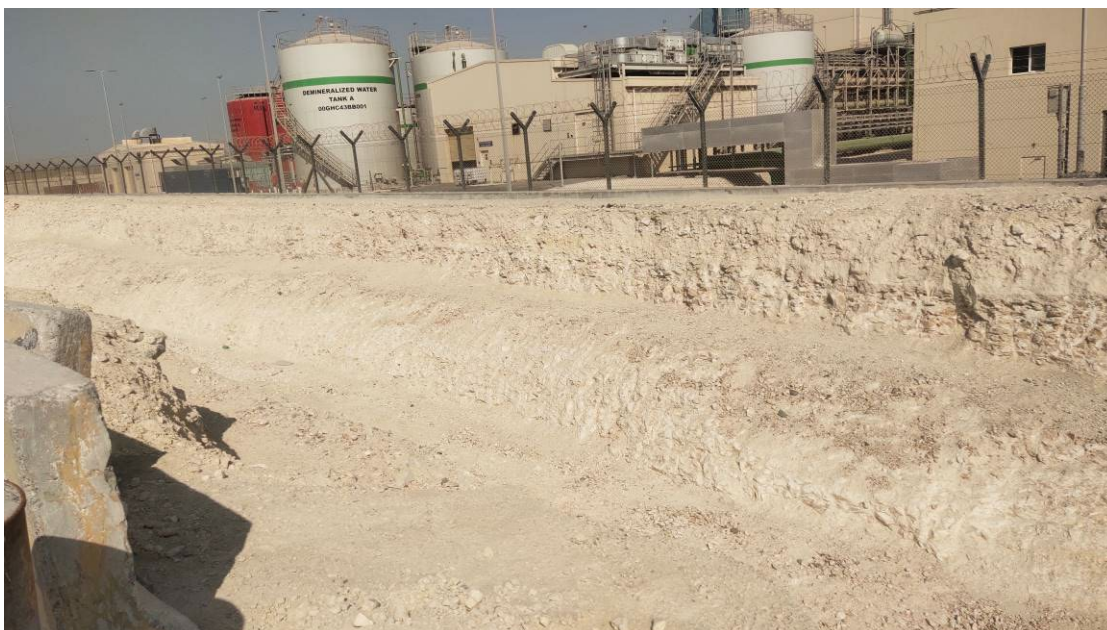
Figure 3.8 Excavation at the boundary of laydown yard and Al Dur Phase II IWPP

A deep excavation exists (**Figure 3.8**) to the north of the laydown yard. No standing water or contamination was observed in this excavation.

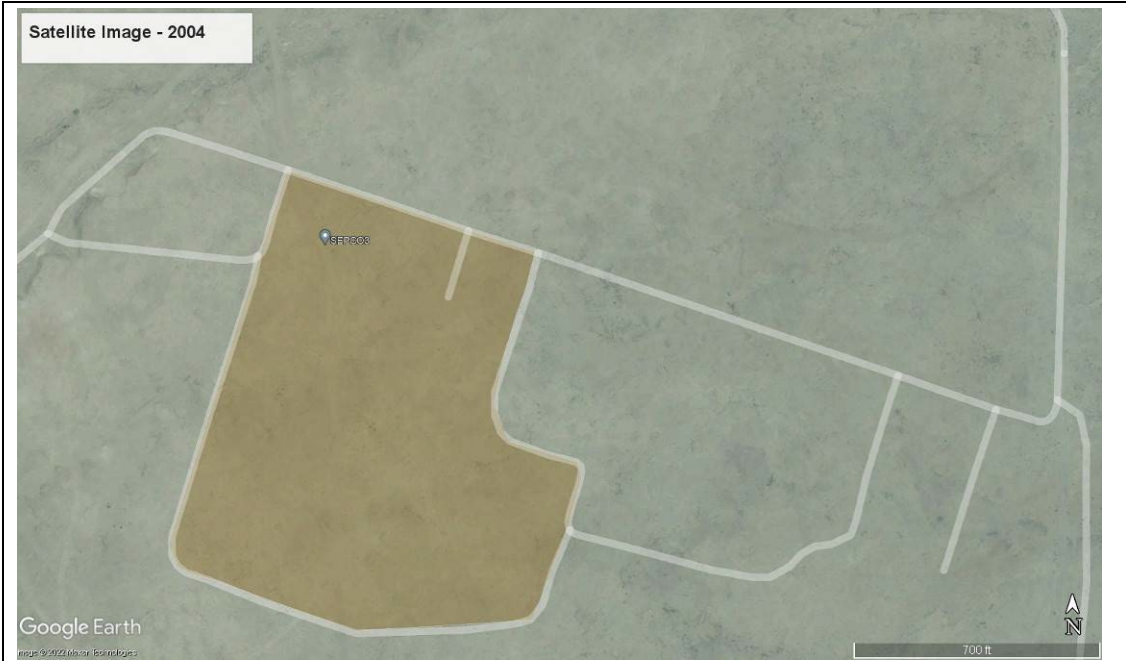
2004	Satellite image shows the laydown yard is an empty unused land parcel. No developments on the north, east, west and south of the yard.
------	--

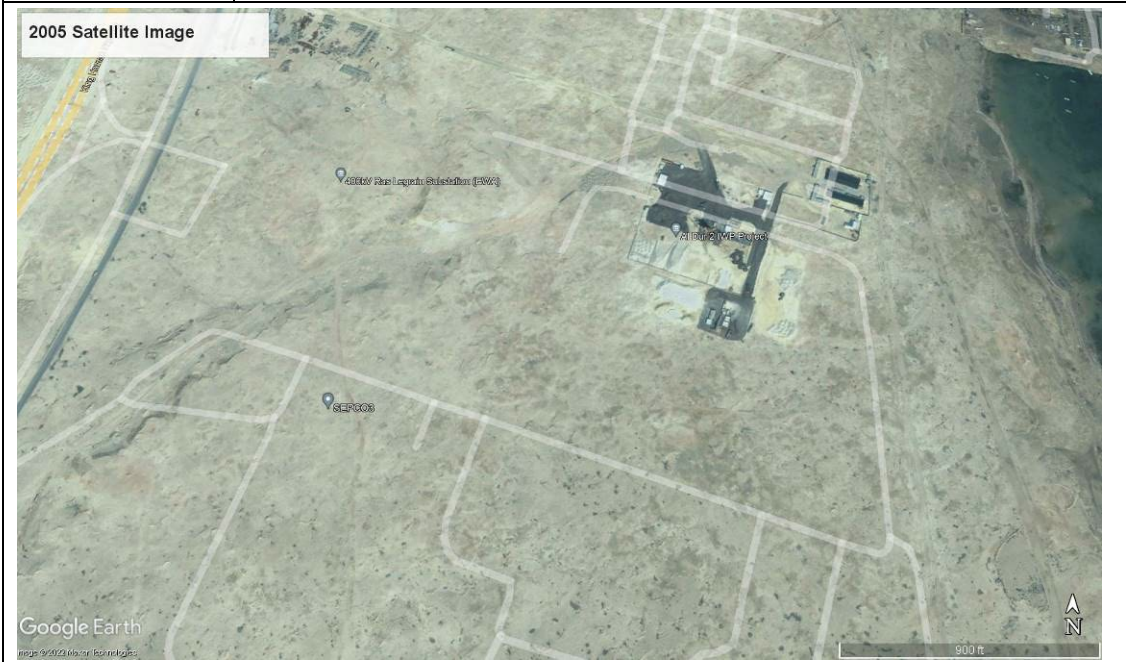
2005	Satellite image shows the laydown yard is an empty unused land parcel. However, to the north site preparation / construction works of Al Dur Phase I IWPP is in progress. No developments to the south, west and east of the location.
------	--

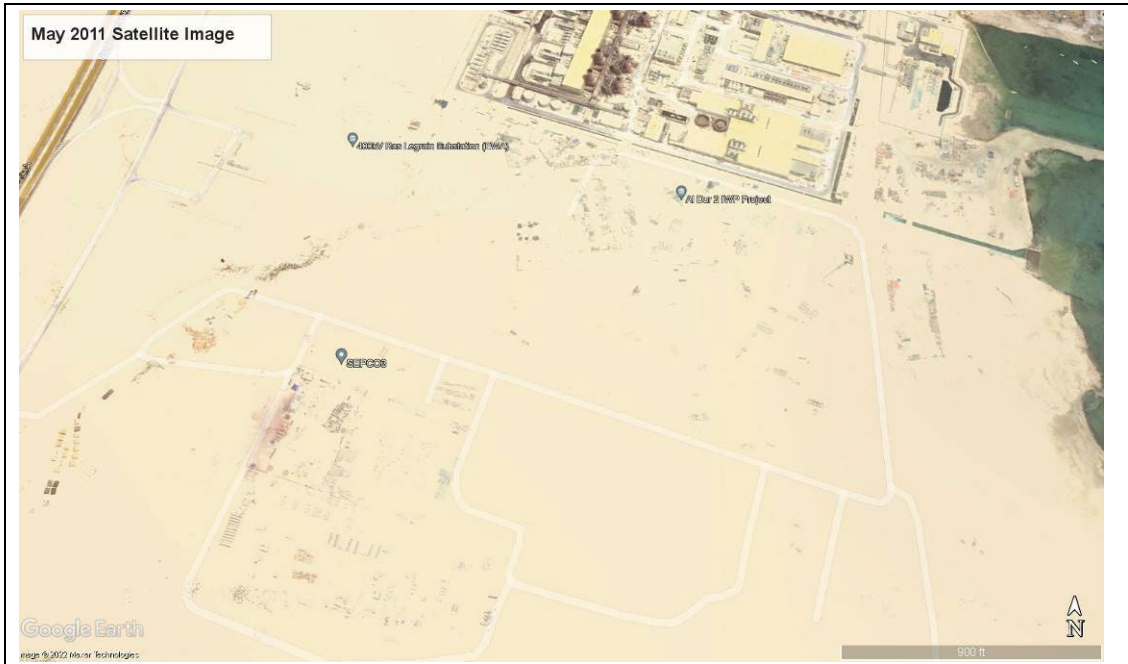
May 2011

Satellite image shows activity the laydown yard still functioning. Construction work of Al Dur Phase I IWPP is in progress. No developments on south and east of the location. Material storage area to the west of the laydown yard.

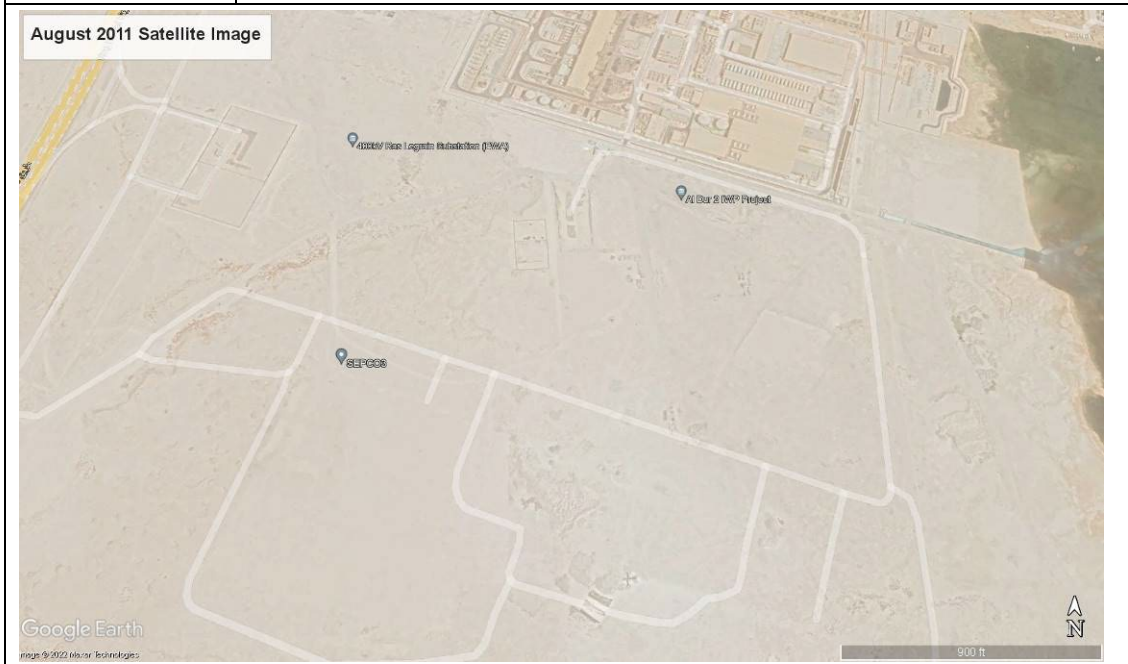
August 2011

Satellite image shows the laydown yard demobilization completed. No activity in the land parcel. Al Dur Phase I IWPP construction works completed. No developments to the south, east and west of the laydown yard.

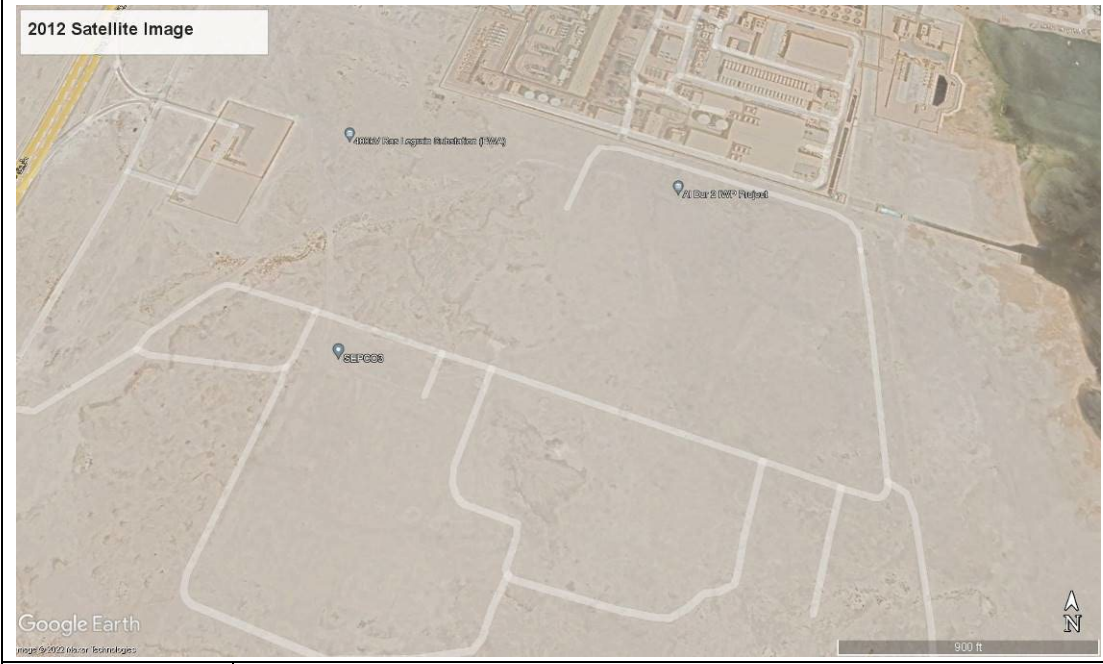
<p>2012 Satellite Image</p>

<p>2012</p>	<p>Satellite image shows the laydown yard is an empty unused land parcel. No developments on the north, east, west and south of the yard.</p>
<p>2013 Satellite Image</p>

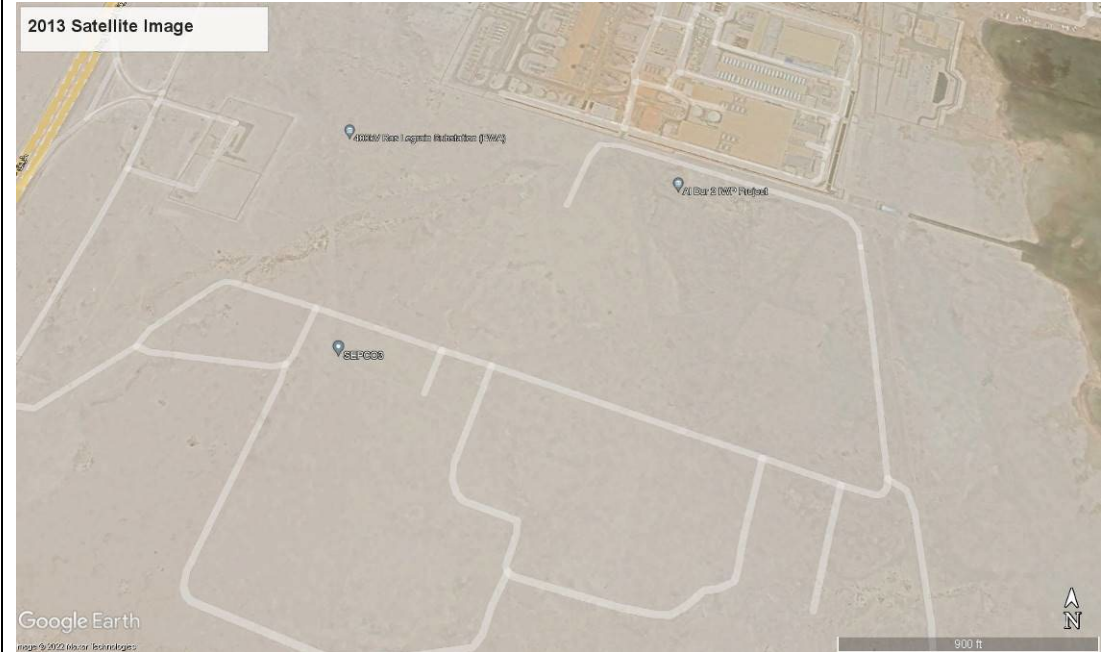
<p>2013</p>	<p>Satellite image shows the laydown yard is an empty unused land parcel. No developments on the north, east, west and south of the yard.</p>

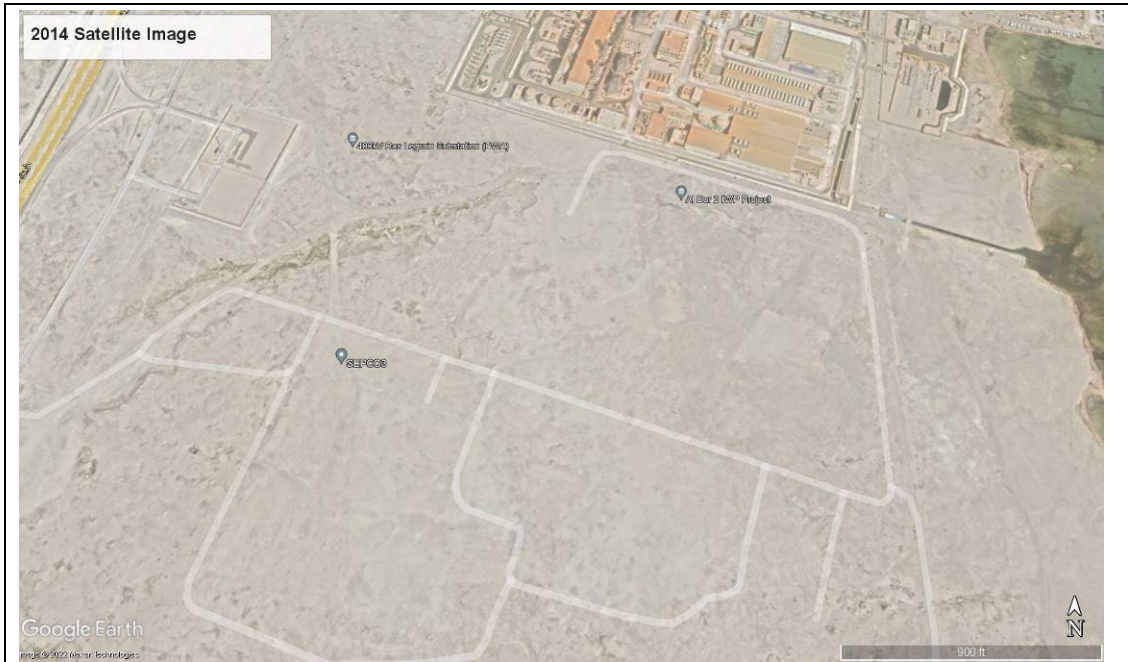
2014	Satellite image shows the laydown yard is an empty unused land parcel. No developments on the north, east, west and south of the yard.
------	--

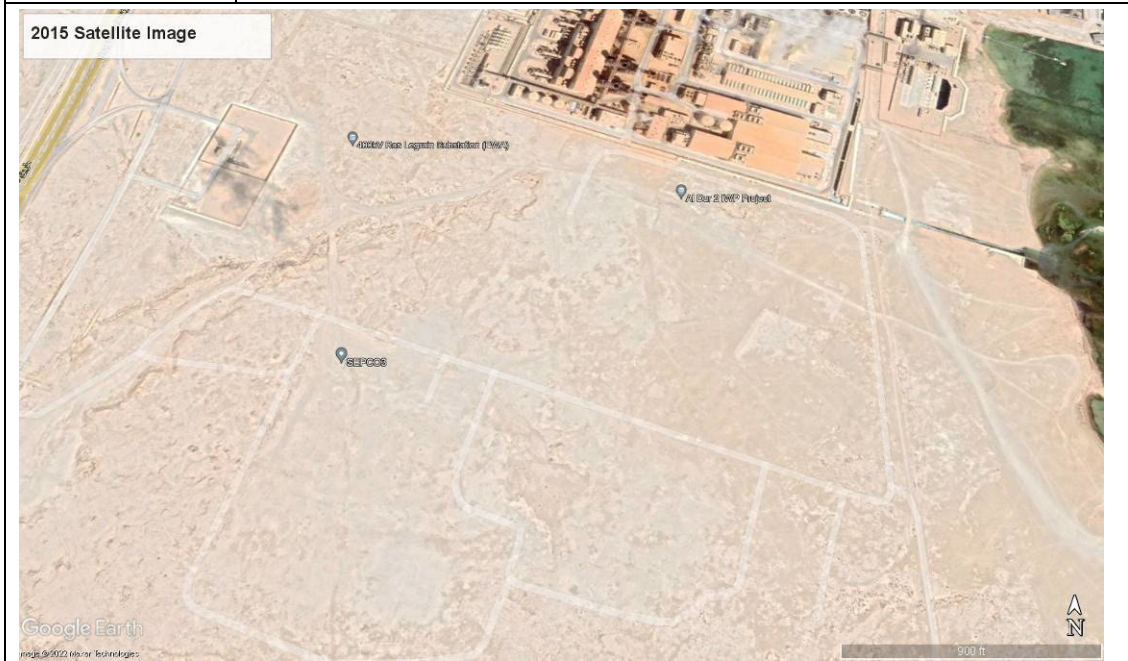
2015	Satellite image shows the laydown yard is an empty unused land parcel. No developments on the north, east, west and south of the yard.
------	--

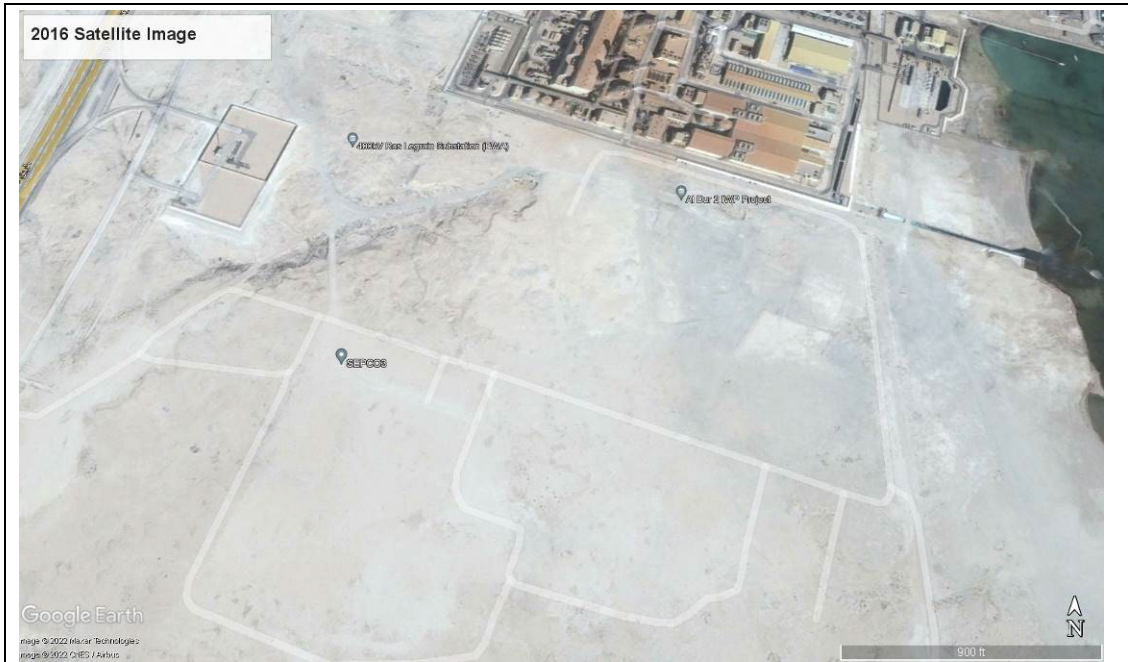
2016	Satellite image shows the laydown yard is an empty unused land parcel. No developments on the north, east, west and south of the yard.
------	--

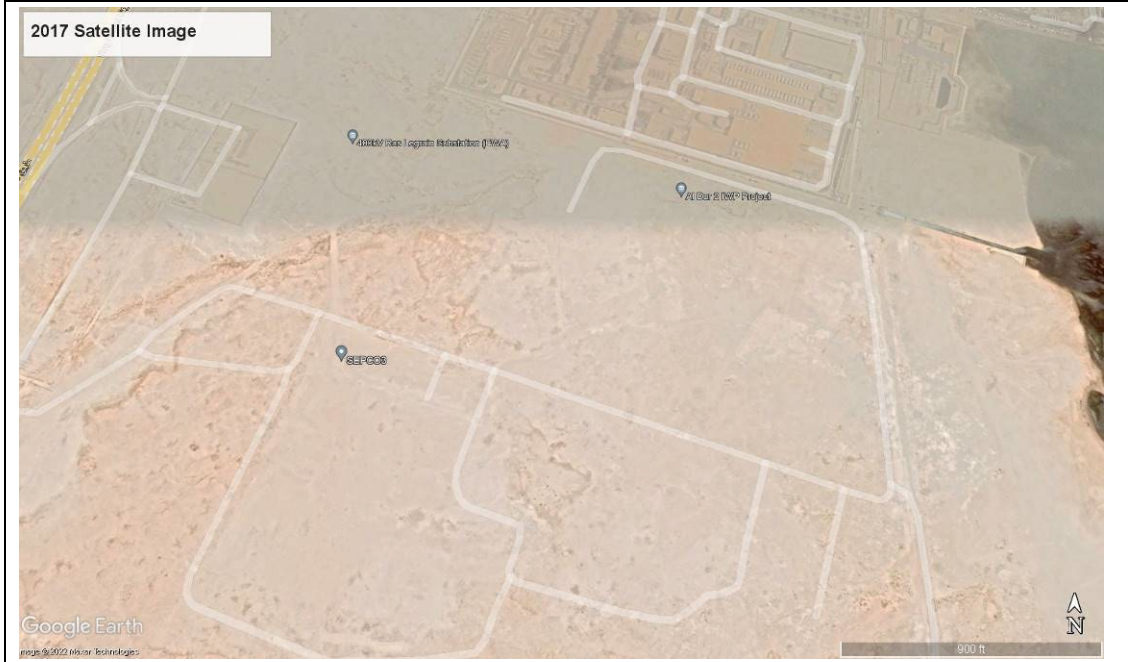
2017	Satellite image shows the laydown yard is an empty unused land parcel. No developments on the north, east, west and south of the yard.
------	--

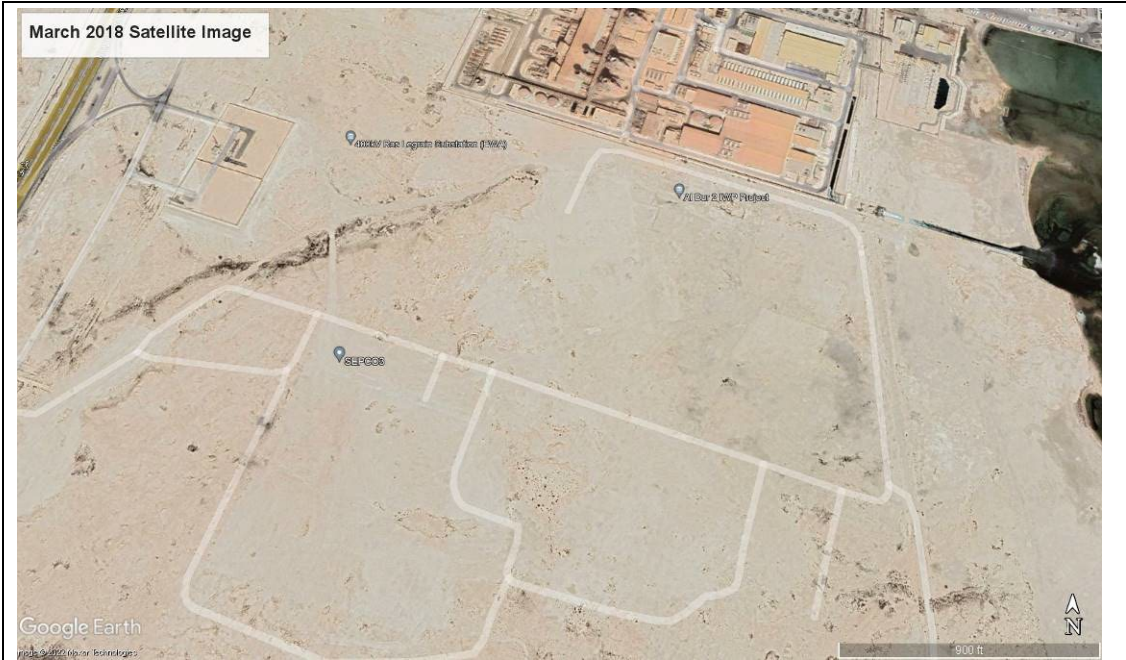
<p>March 2018</p>	<p>Satellite image shows the laydown yard is an empty unused land parcel. No developments on the north, east, west and south of the yard.</p>
-------------------	---

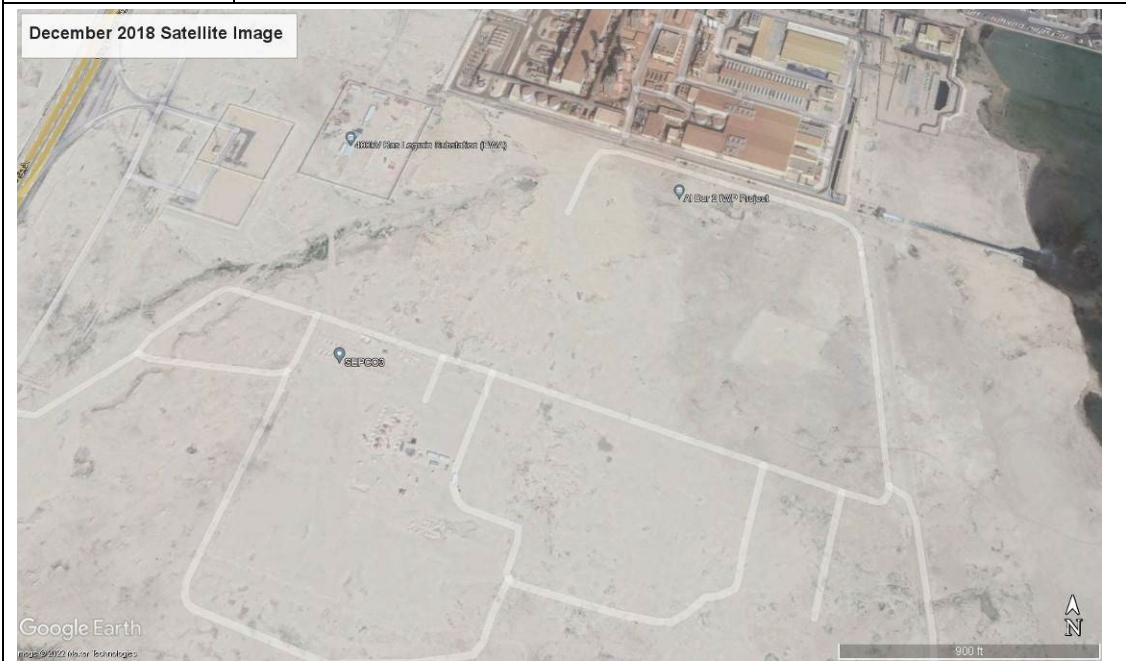
<p>December 2018</p>	<p>Satellite image shows the mobilization of the current laydown yard started. Construction works of Al Dur Phase II IWPP started which is located to the north. No developments on the east, west and south of the yard.</p>
----------------------	---

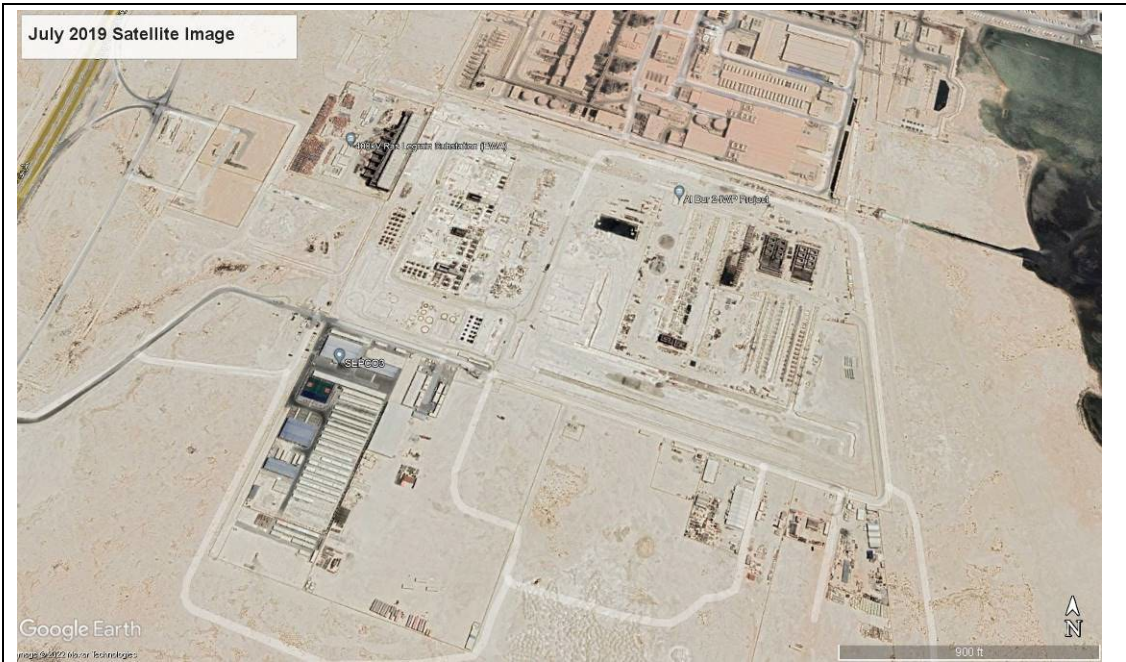
July 2019

Satellite image shows that SEPCO III accommodation, site offices and laydown area are in operation. Construction works of Al Dur Phase II IWPP is in progress. Land parcel to the east is assigned as laydown yard for the water plant. No developments on the west and south of the yard.

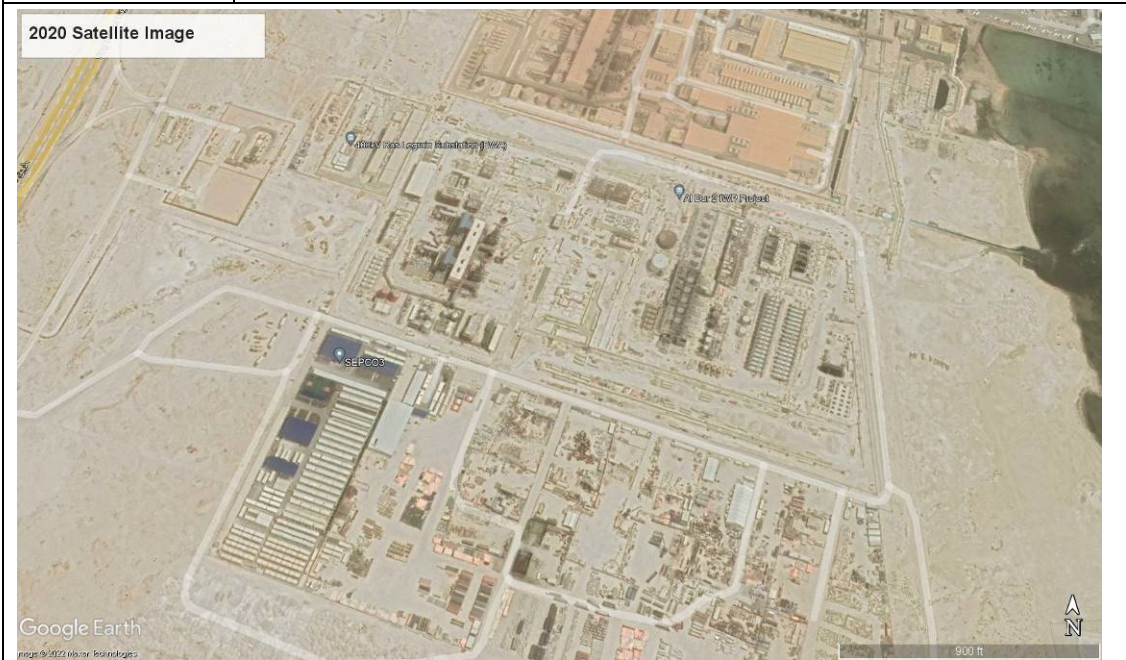
2020

Satellite image shows that SEPCO III accommodation and site offices are in operation. Laydown yard is fully occupied. Construction works of Al Dur Phase II IWPP is in progress. Land parcel to the east is assigned as laydown yard for the water plant. No developments on the west and south of the yard.

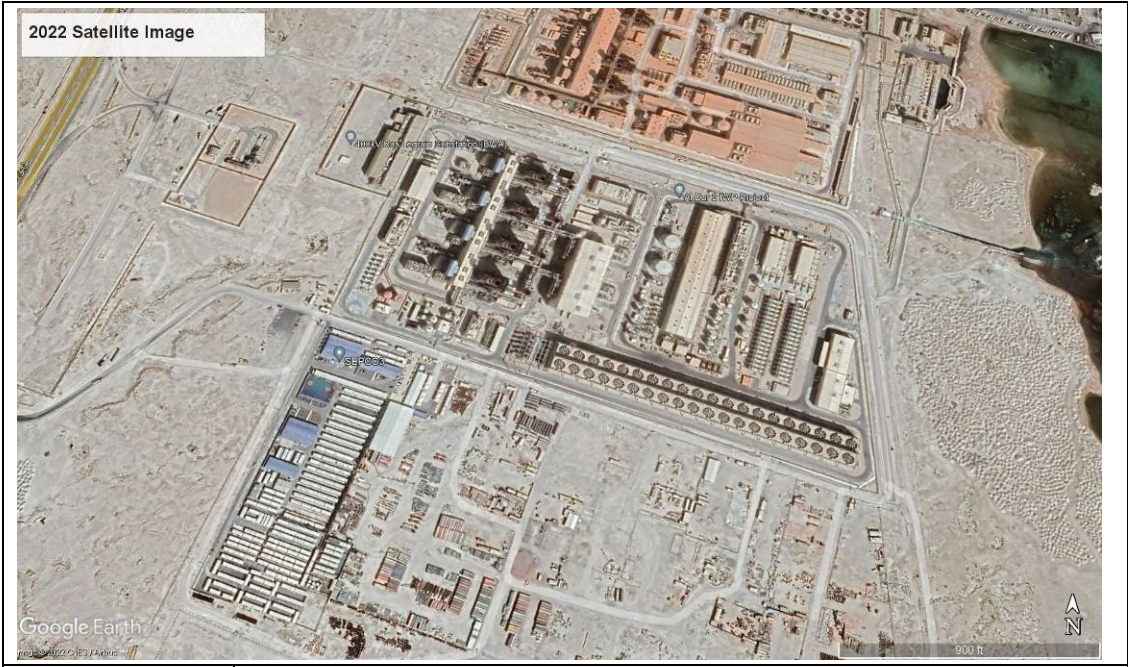
<p>2022 Satellite Image</p>

<p>2022</p>	<p>Satellite image shows that SEPCO III accommodation and site offices are in operation. Laydown yard is fully occupied. Construction works of Al Dur Phase II IWPP is in progress. Demobilization started at the laydown yard located to the east. No developments on the west and south of the yard.</p>
