## Alba Power Station 5 Block 4 Supplementary ESIA Contaminated Land Risk Assessment

January 2023 1B0114204 Rev. 00

| Title | Alba Power Station 5 Block 4<br>Contaminated Land Risk Assessment |

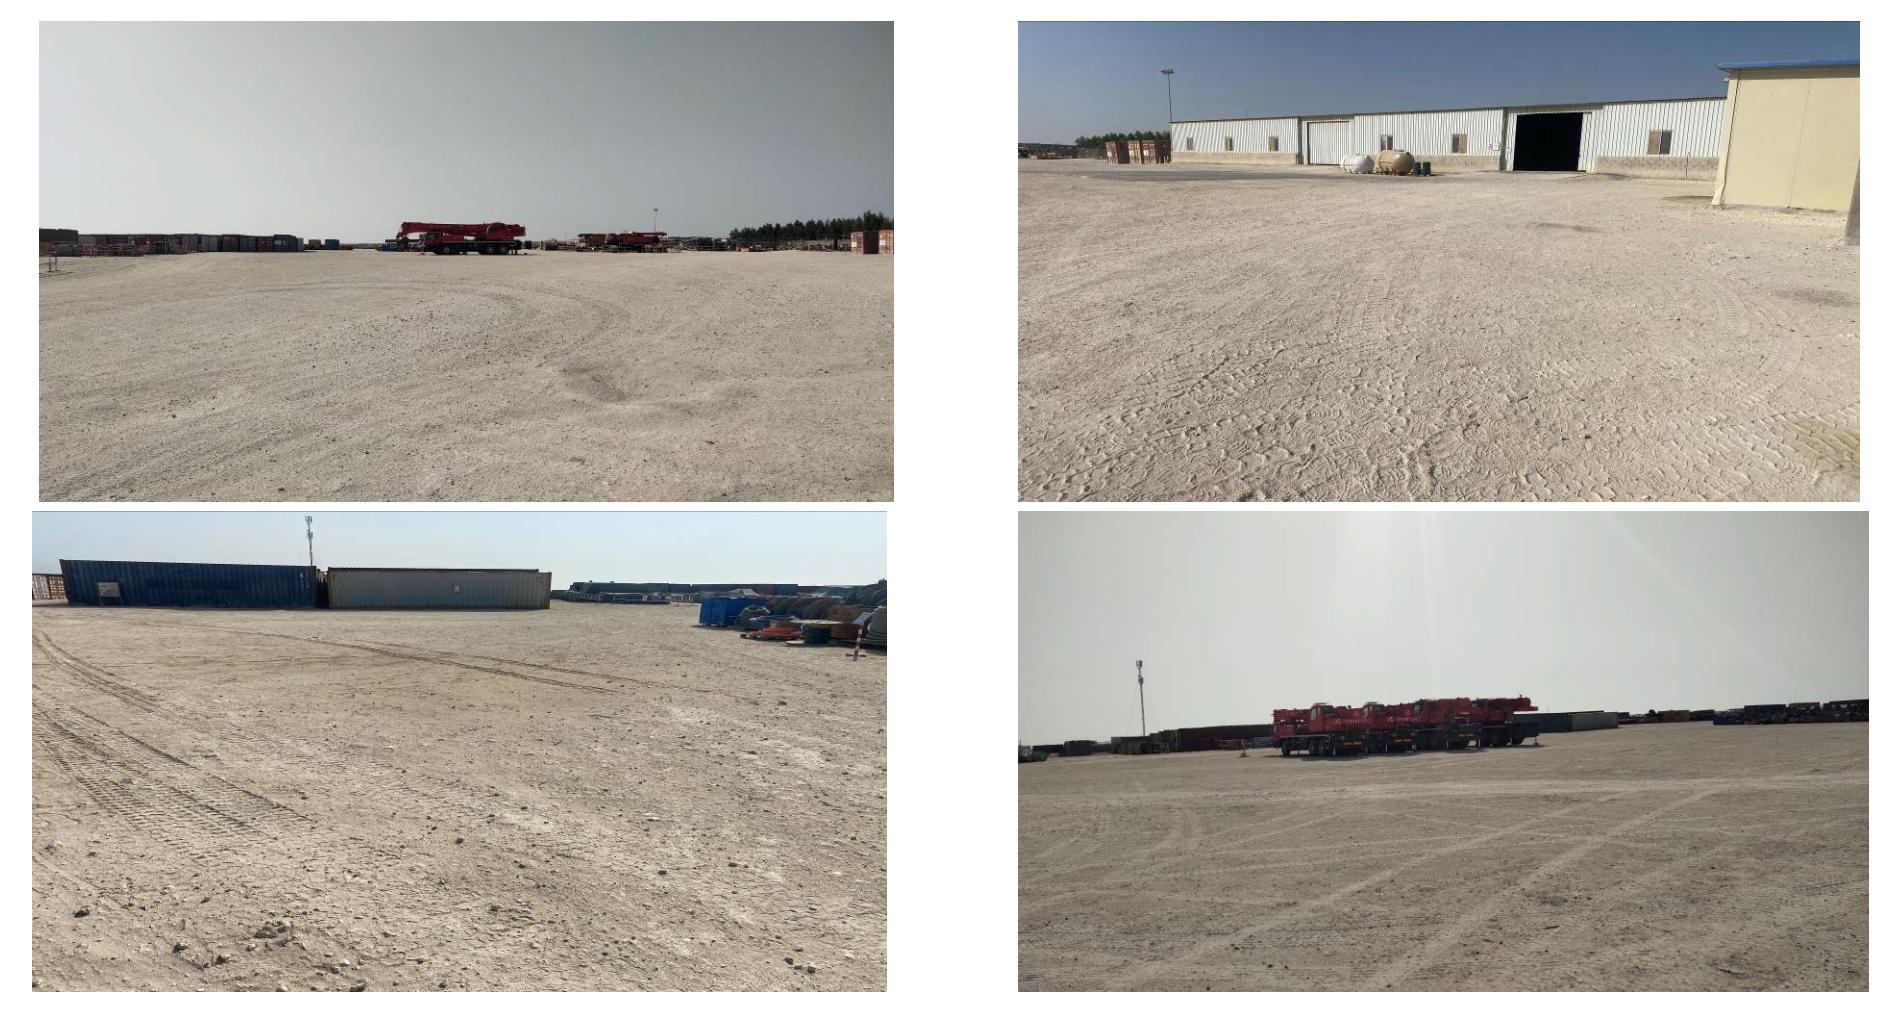
## Figure 3.3 Photographs from site walkover

The purpose of the site visit and walkover was to observe current utilization of the laydown yard including current usage, storage of materials, generation of hazardous materials, the storage and handling of generated waste and the storage of waste water.

The laydown yard footprint appears to have limited past use. From the review of historical satellite imagery of the location, it is suspected that this land was only been used once previously as a laydown yard during the construction of Al Dur Phase I IWPP as described earlier (**Section 3.4 Appendix 3C**).

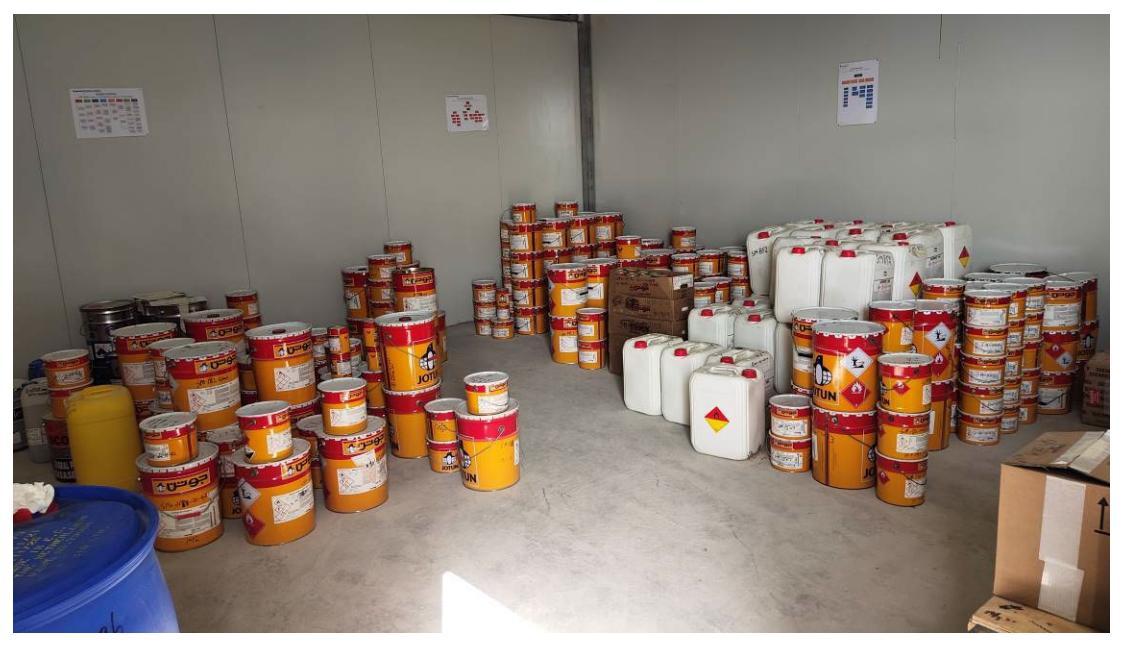
The chemical storage area (**Figure 3.4**) contains an impervious concrete floor, air conditioning, spill kits, fire extinguishers and ventilation. Material such as paint and electrolyte liquids purchased for the AI Dur Phase II IWPP are still stored in the area. However, these materials are owned by First National Operation and Maintenance Co. Ltd. (NOMAC) and will be transferred to the storage area in AI Dur Phase II power plant. The chemical store was clean with no sign of spill or contamination observed on the floor of the warehouse or in adjacent areas.

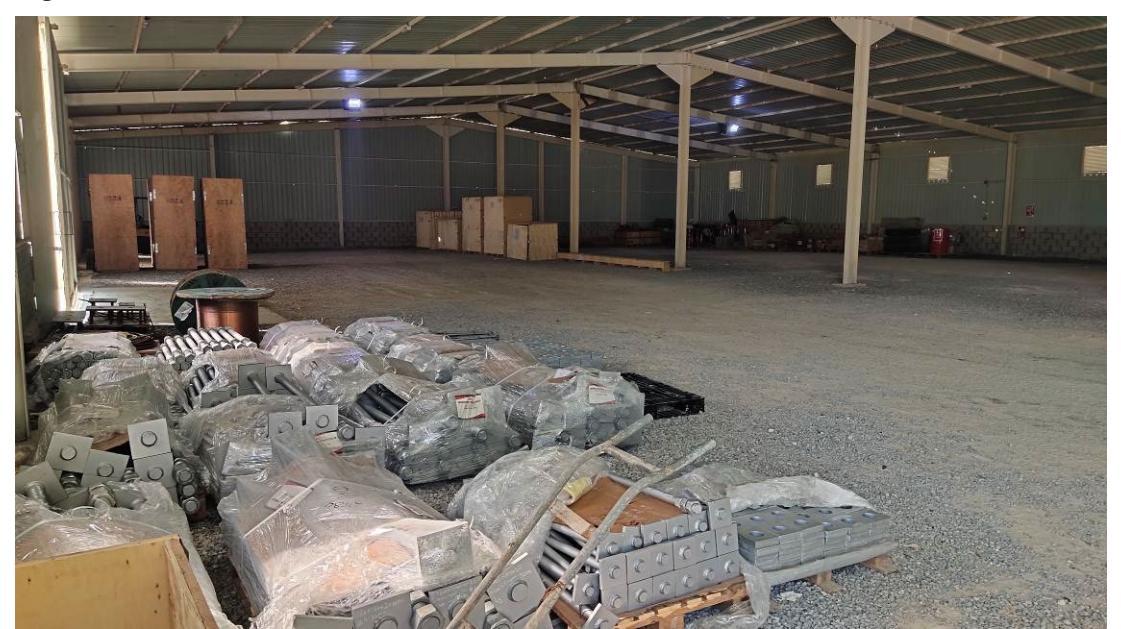
The warehouse was inspected (**Figure 3.5**). Materials for Al Dur Phase II Project remain stored in both the warehouse and open yard. These will be transferred to Al Dur Phase II power plant area. Housekeeping is excellent, the warehouse and open yard were both very well organised with no visible contamination observed on the ground or at adjacent areas.

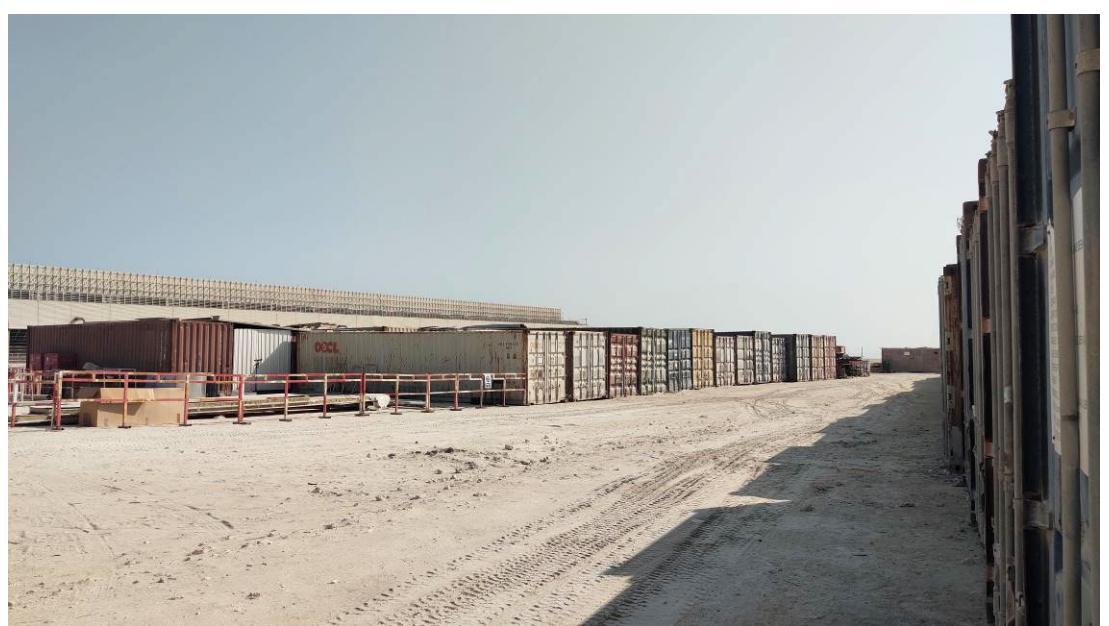
#### Figure 3.6 Storage containers at laydown yard

A total of 130 containers were stored in the open yard during the site visit (**Figure 3.6**). The containers belong to AI Dur Phase II IWPP. Out of 130, 95 containers contain spare parts for AI Dur Phase II IWPP and the balance of 35 are empty. The containers were well organised and the containers and their contents present no risks to the environment.

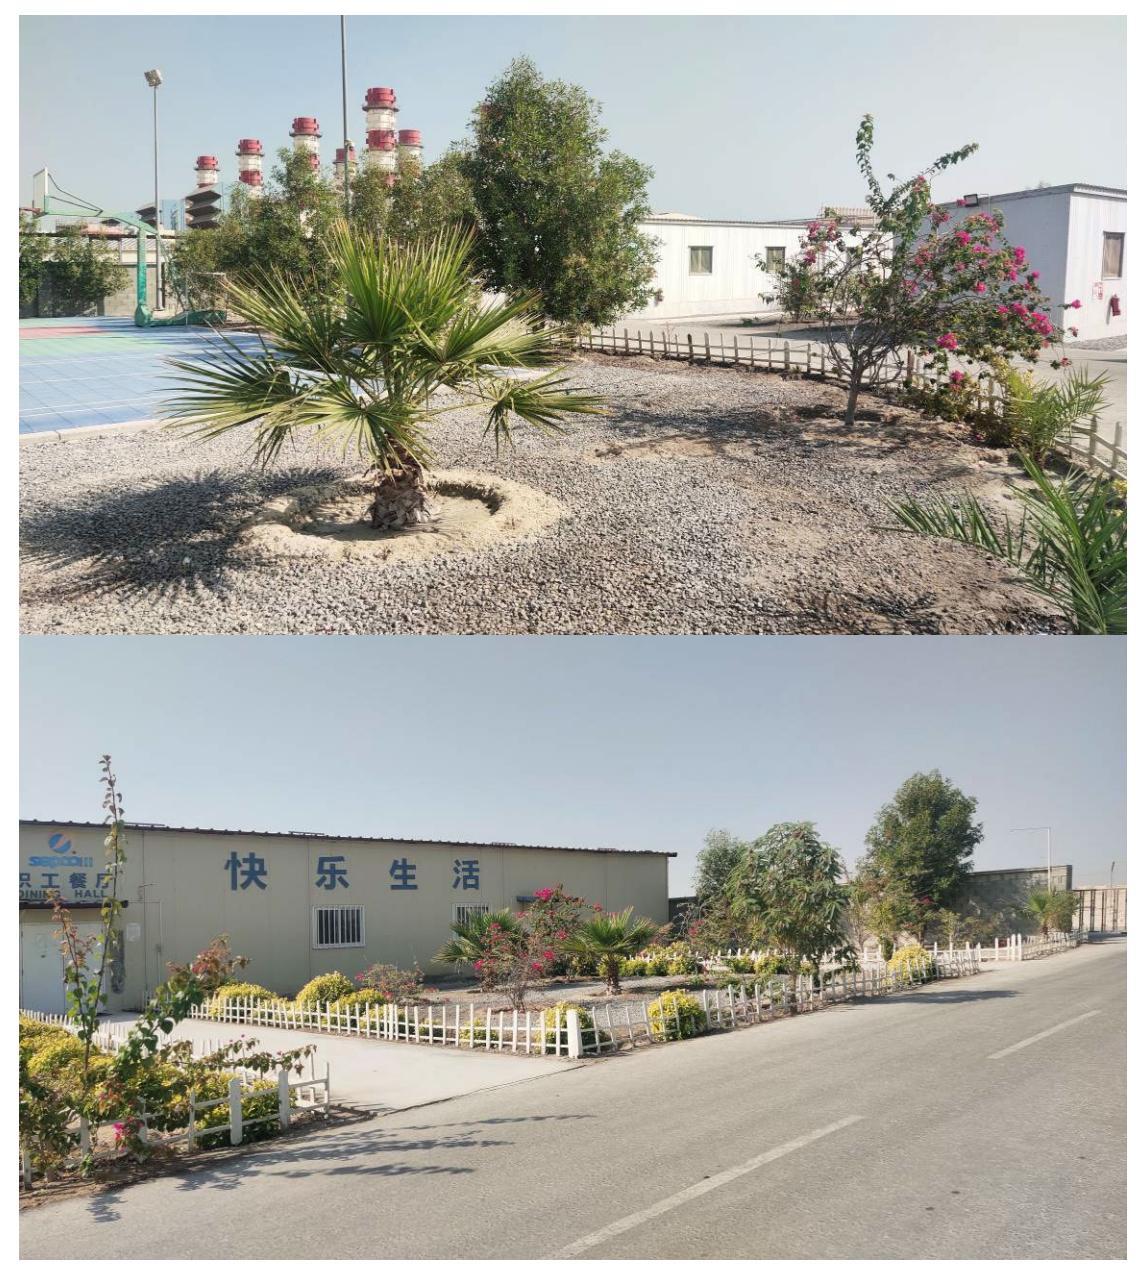
#### Figure 3.7 Vegetation observed at accommodation area

No evidence of historical chemical discharges or releases (i.e., staining or stressed vegetation) was observed during the site visit. Various species of plant are planted in the accommodation area where the laydown yard for Al Dur Phase I IWPP was located (**Figure 3.7**).

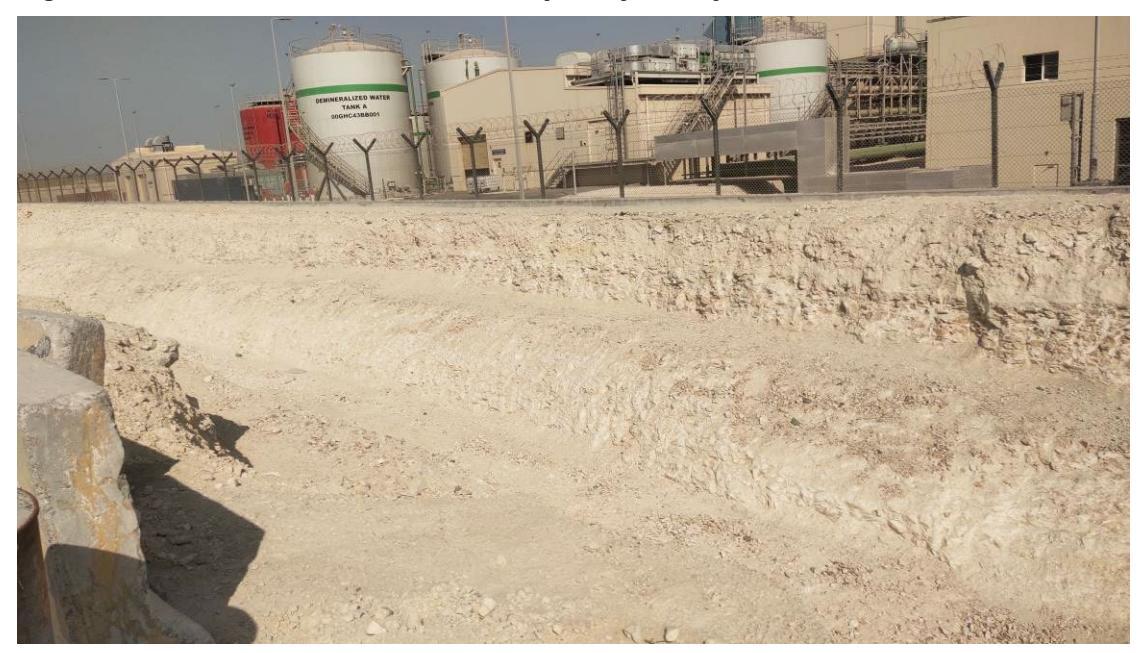
#### Figure 3.8 Excavation at the boundary of laydown yard and AI Dur Phase II IWPP

A deep excavation exists (**Figure 3.8**) to the north of the laydown yard. No standing water or contamination was observed in this excavation.
