Alba Power Station 5 Block 4 Supplementary ESIA Contaminated Land Risk Assessment

January 2023
1B0114202
Rev. 01_Final

Title	Alba Power Station 5 Block 4 Contaminated Land Risk Assessment
Date	23 January 2023
Author	Rajith Chandran

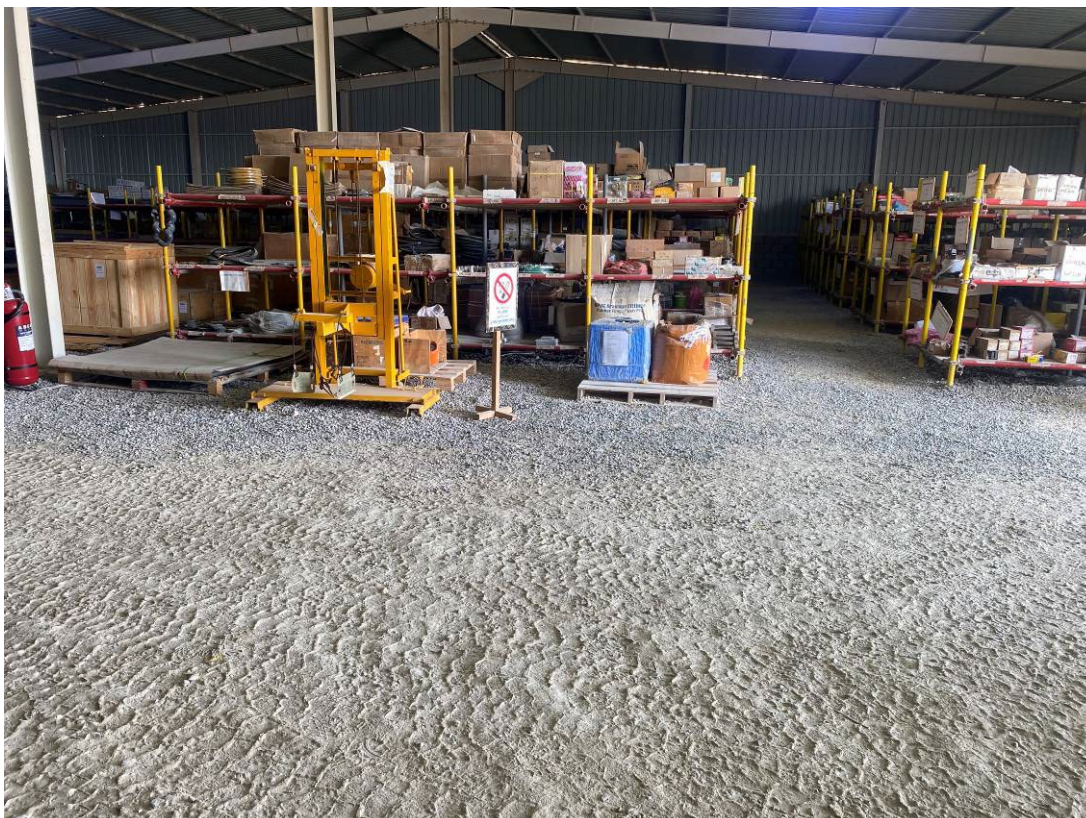
Figure 3.5 Warehouse

The warehouse was inspected (**Figure 3.5**). Materials for Al Dur Phase II Project remain stored in both the warehouse and open yard. These will be transferred to Al Dur Phase II power plant area. Housekeeping is excellent, the warehouse and open yard were both very well organised with no visible contamination observed on the ground or at adjacent areas.

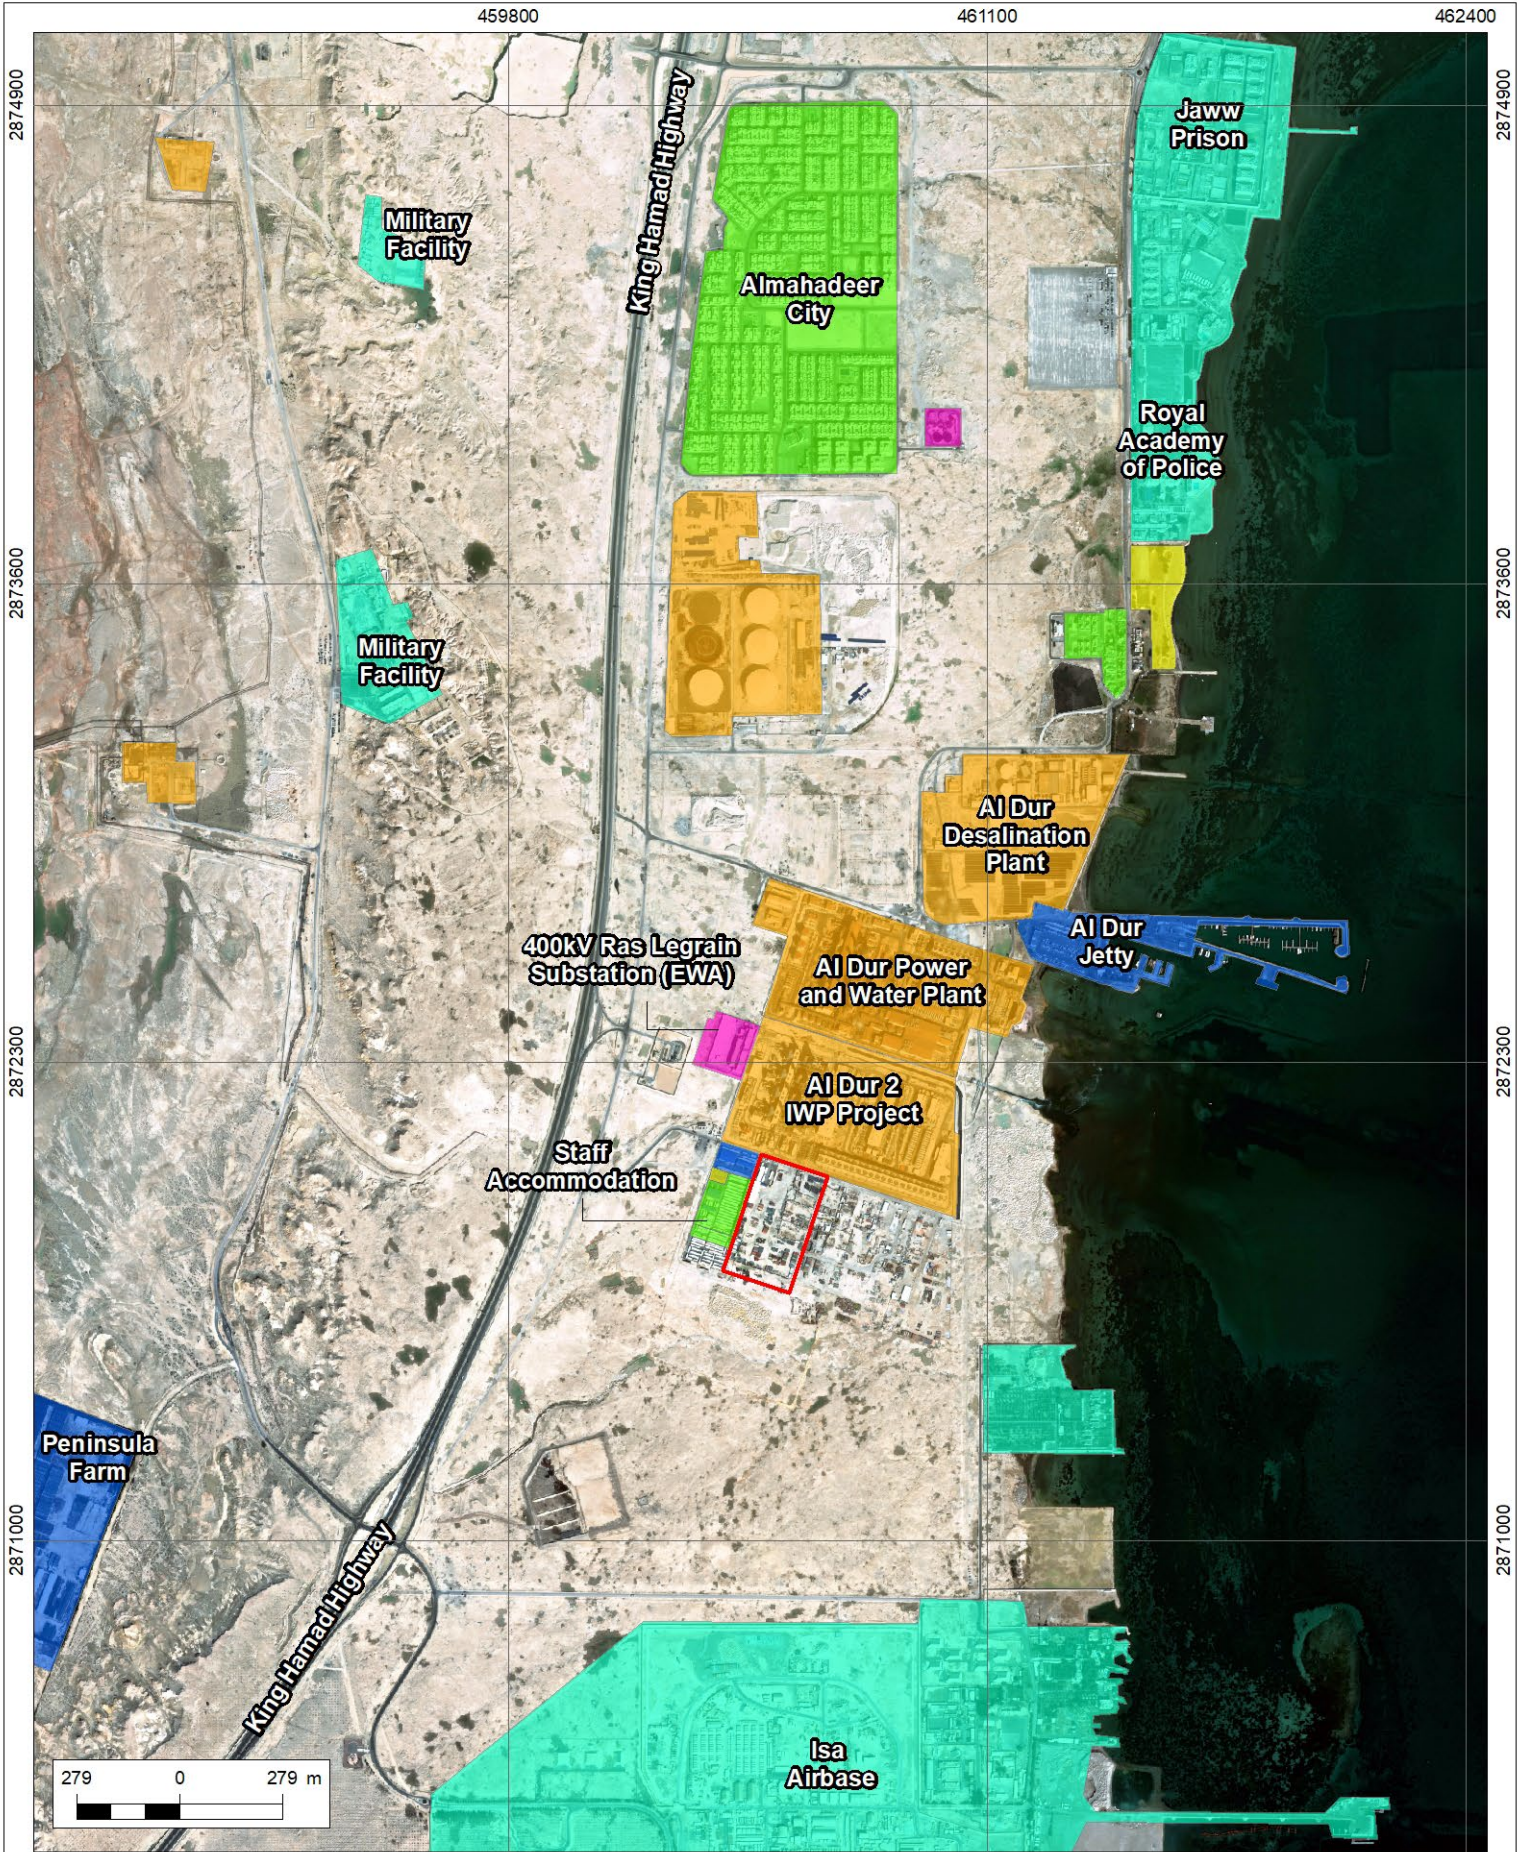
To the east, south and west is vacant land. Al Dur Phase II IWPP and Phase I IWPP are located to the north of laydown yard (**Figure 3.9**).
