## Alba Power Station 5 Block 4 Supplementary ESIA Contaminated Land Risk Assessment

January 2023 1B0114204 Rev. 00

| Title | Alba Power Station 5 Block 4<br>Contaminated Land Risk Assessment |

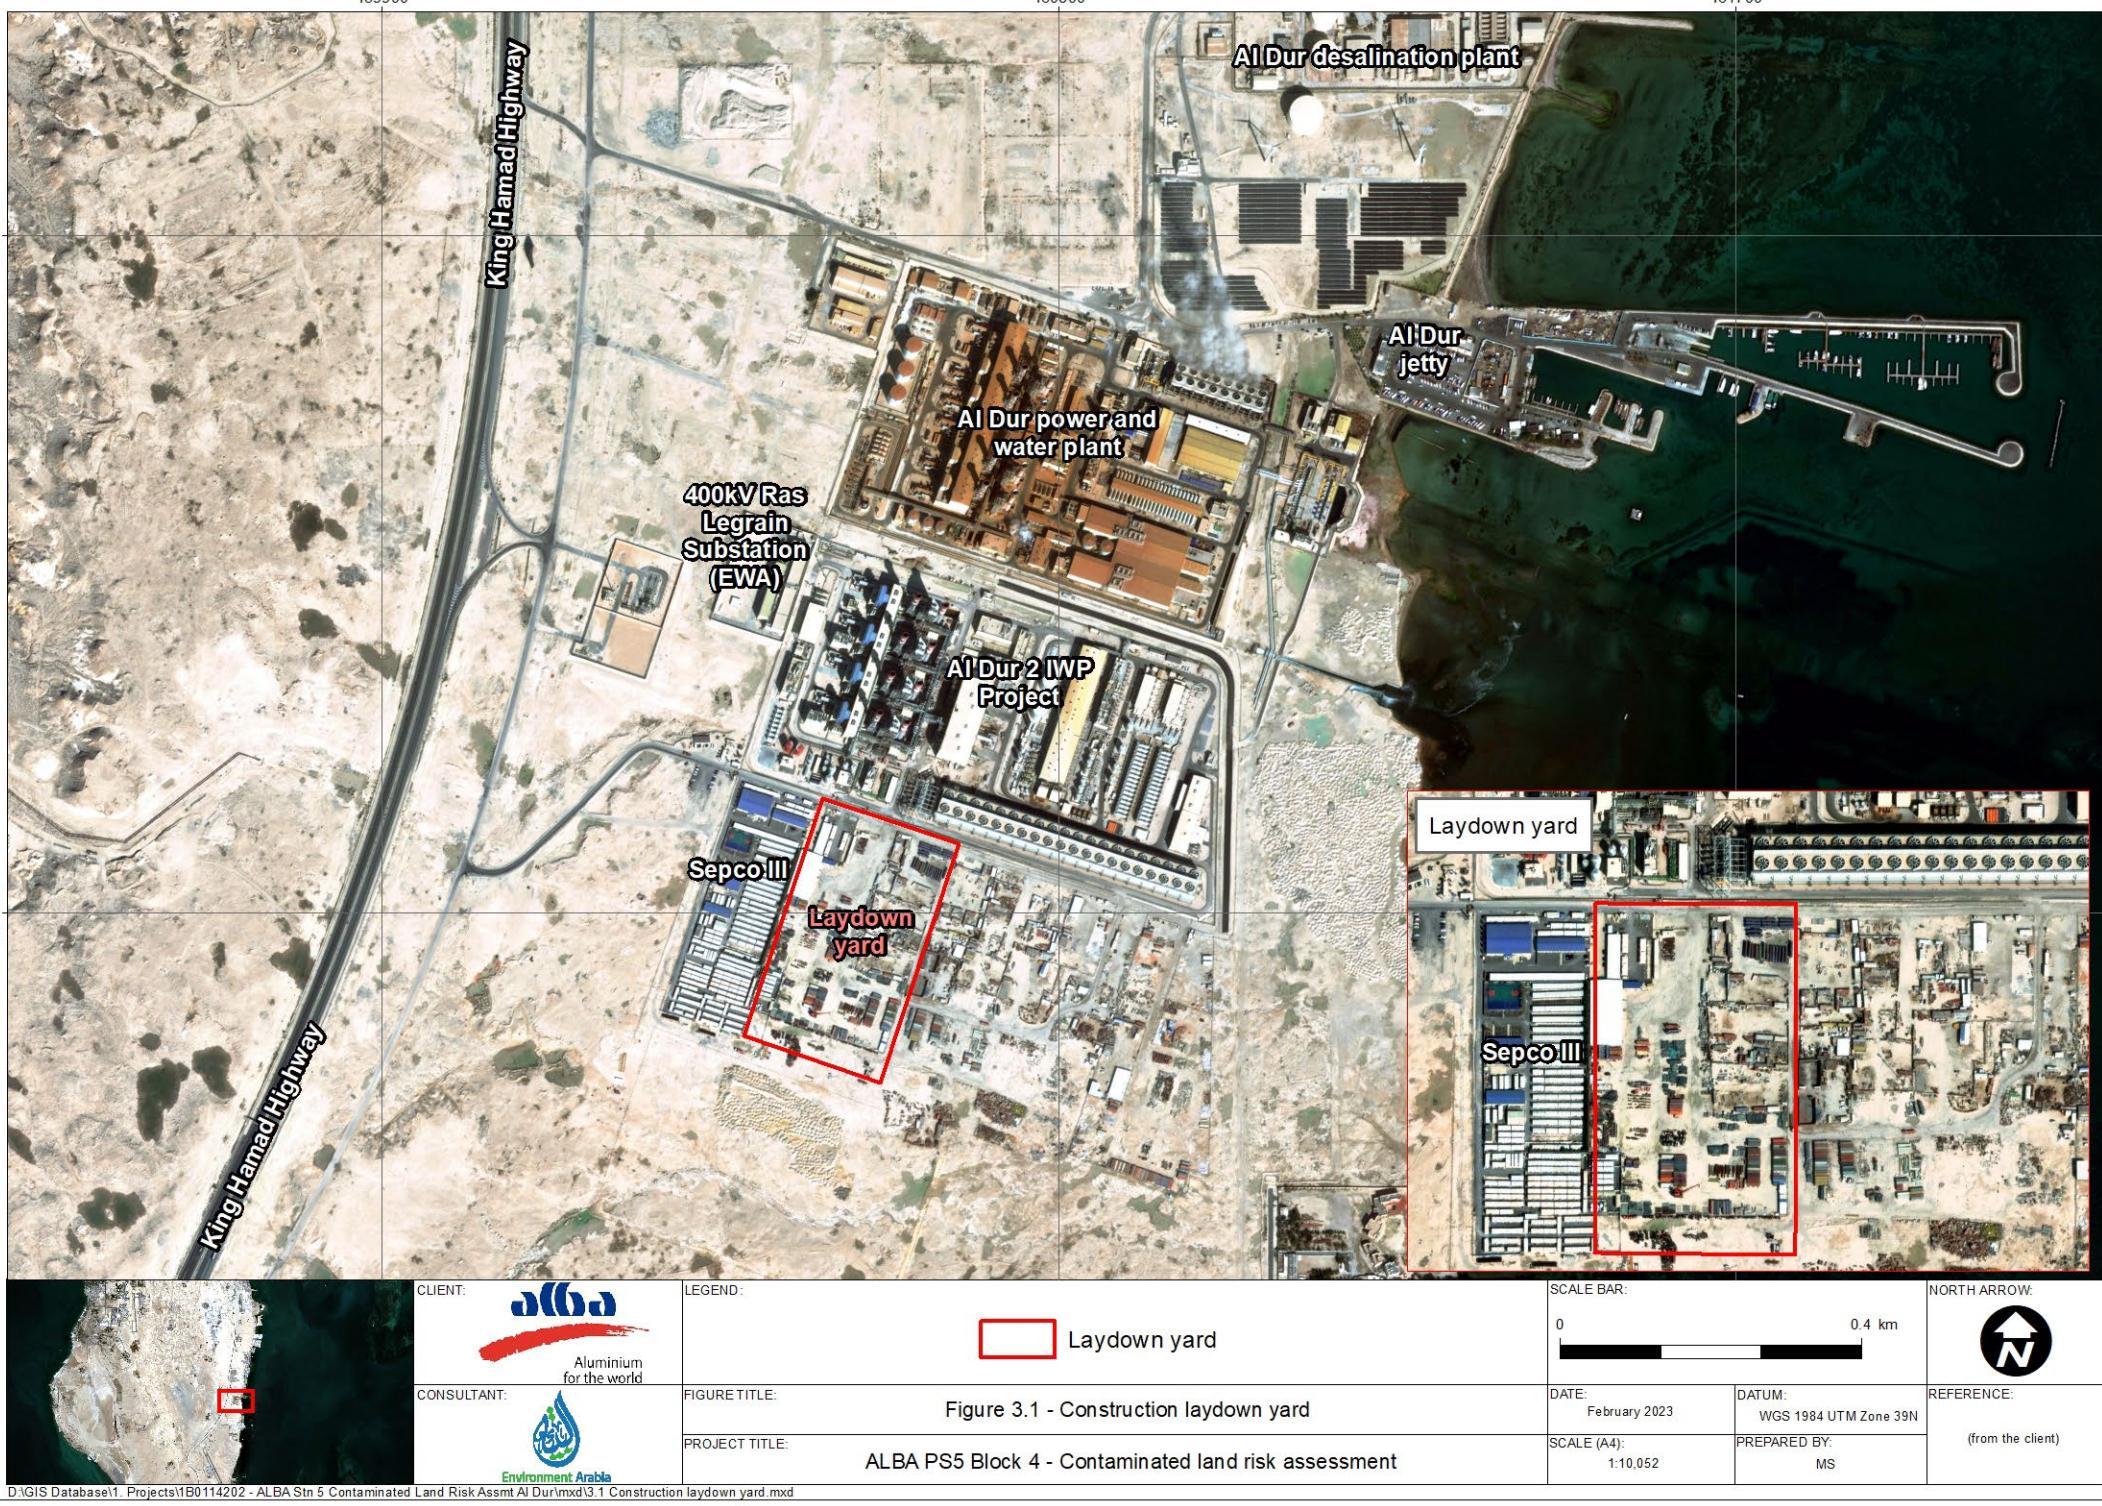
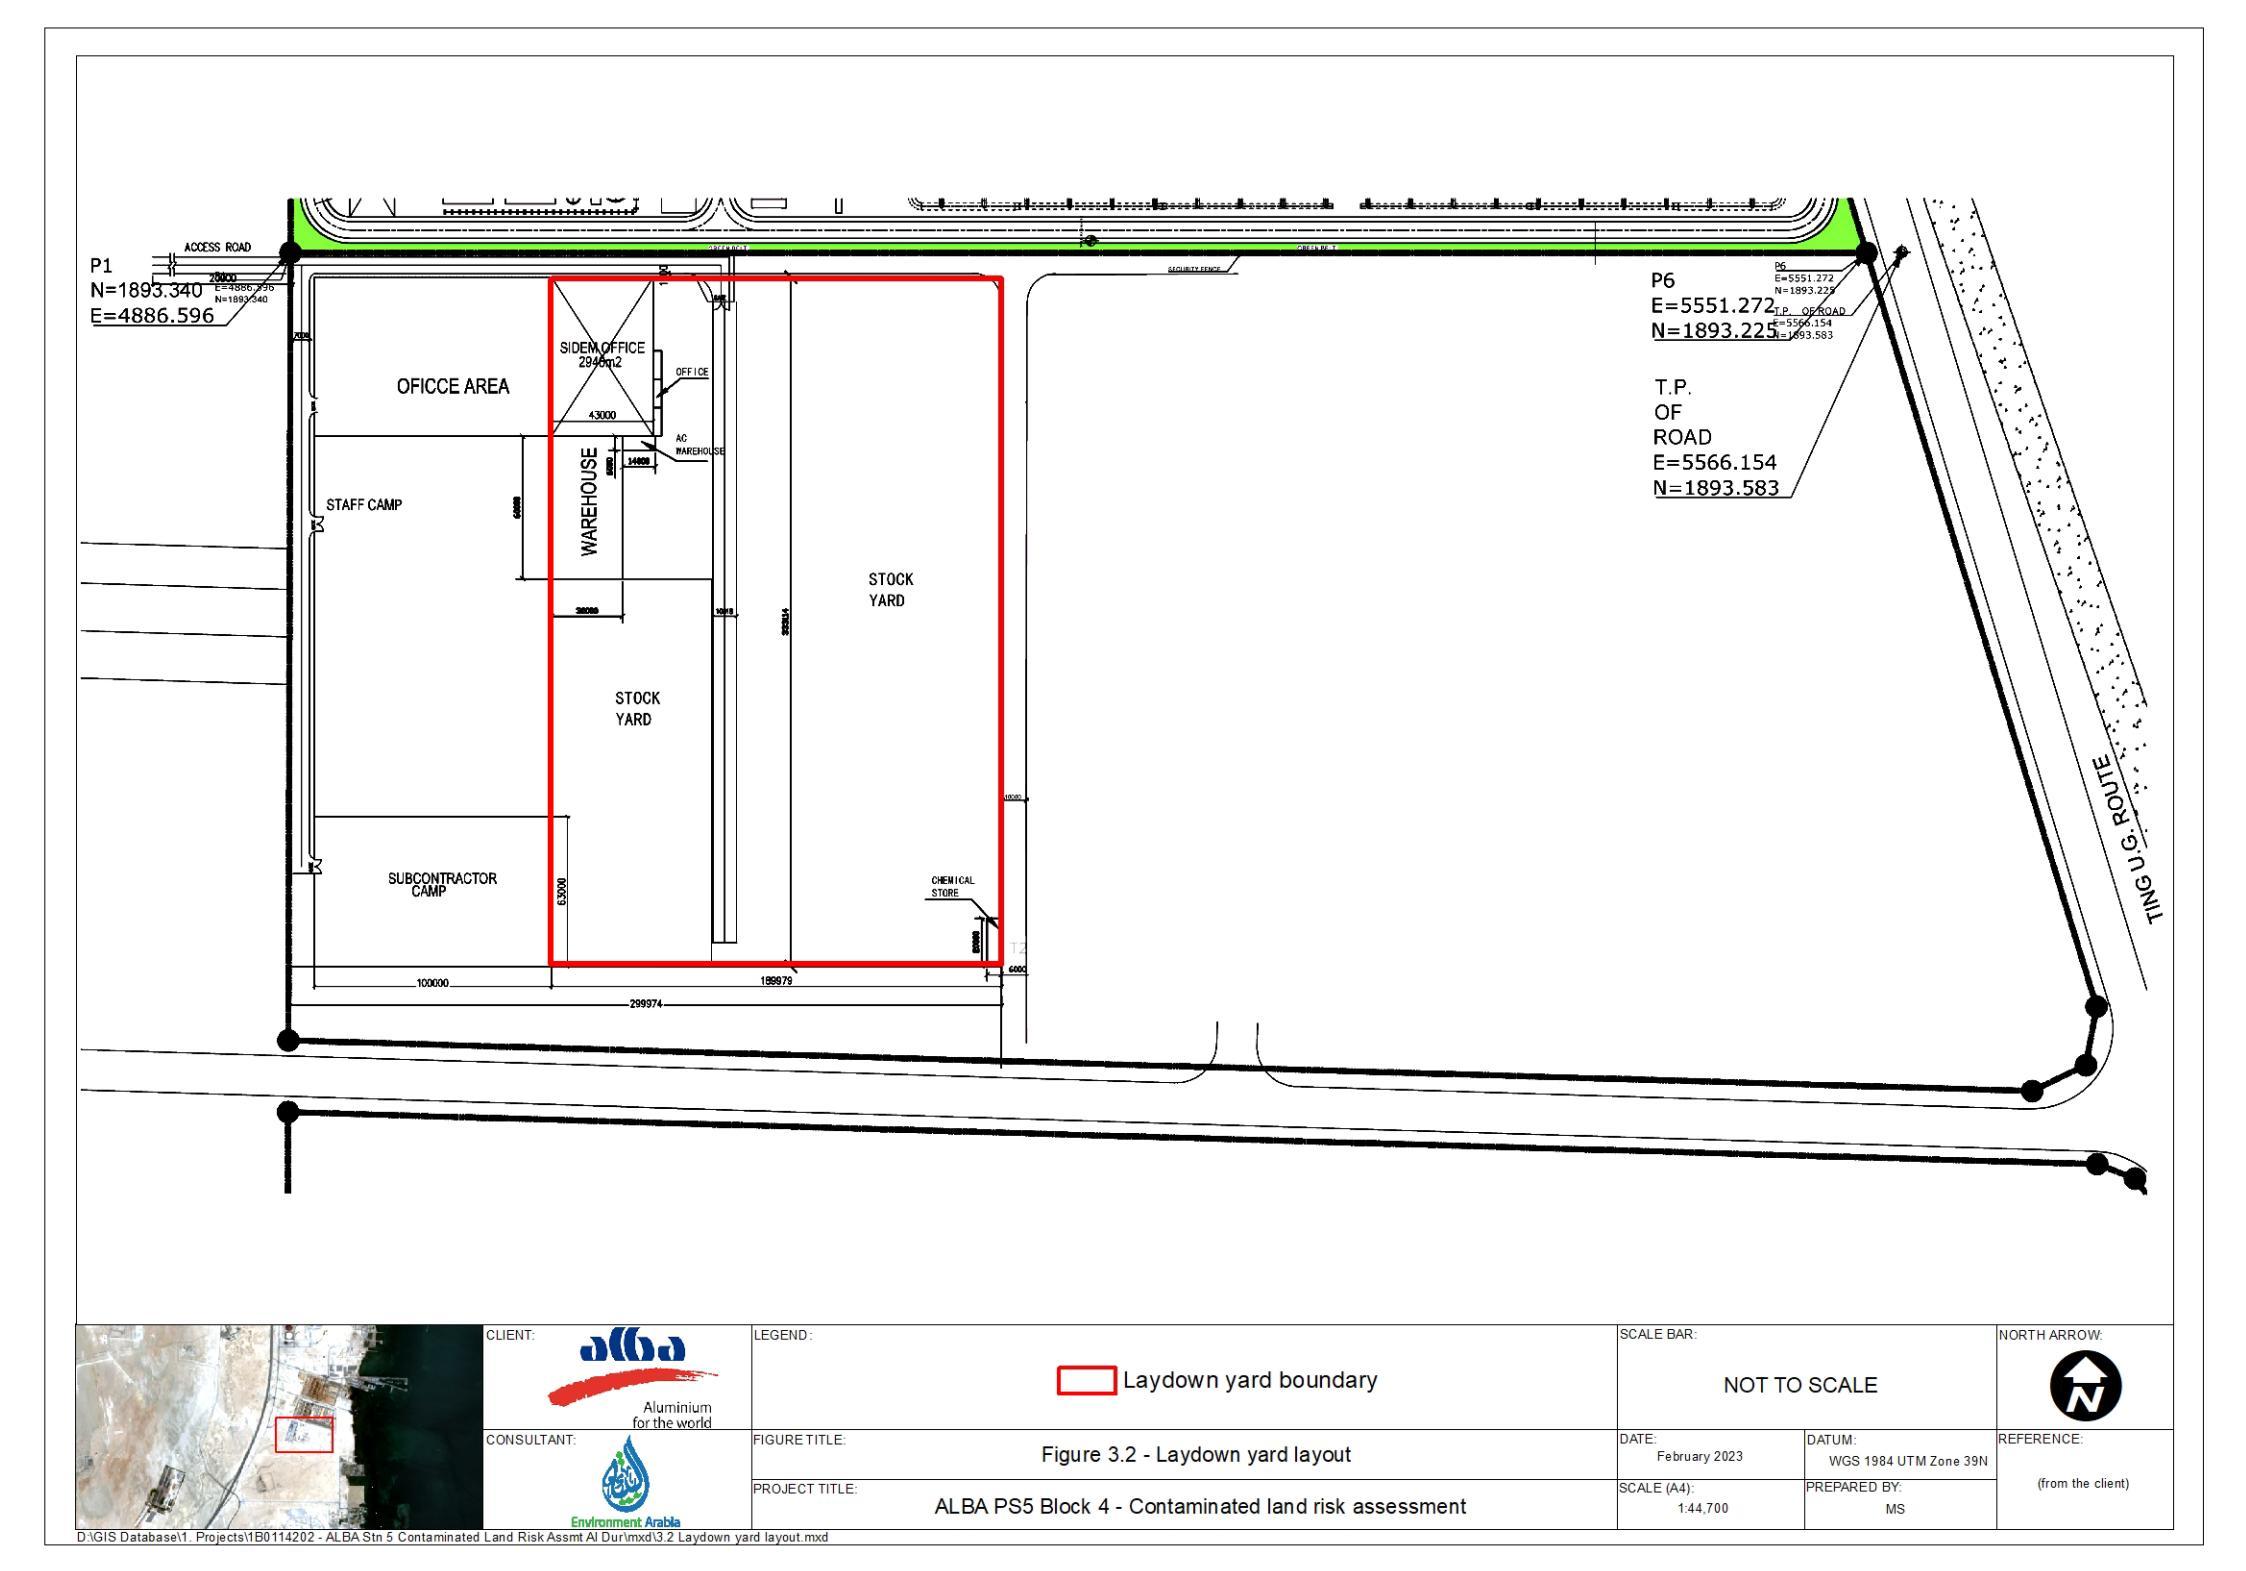
## Figure 3.3 Photographs from site walkover

EACS, Alba and SEPCO III representatives conducted a joint walkover across the laydown yard and accommodation area on 13<sup>th</sup> November 2022. Photographs were taken during the walkover and are presented in **Figure 3.3** and **Appendix 3B**.
